# Spot Repair System

## Produkt

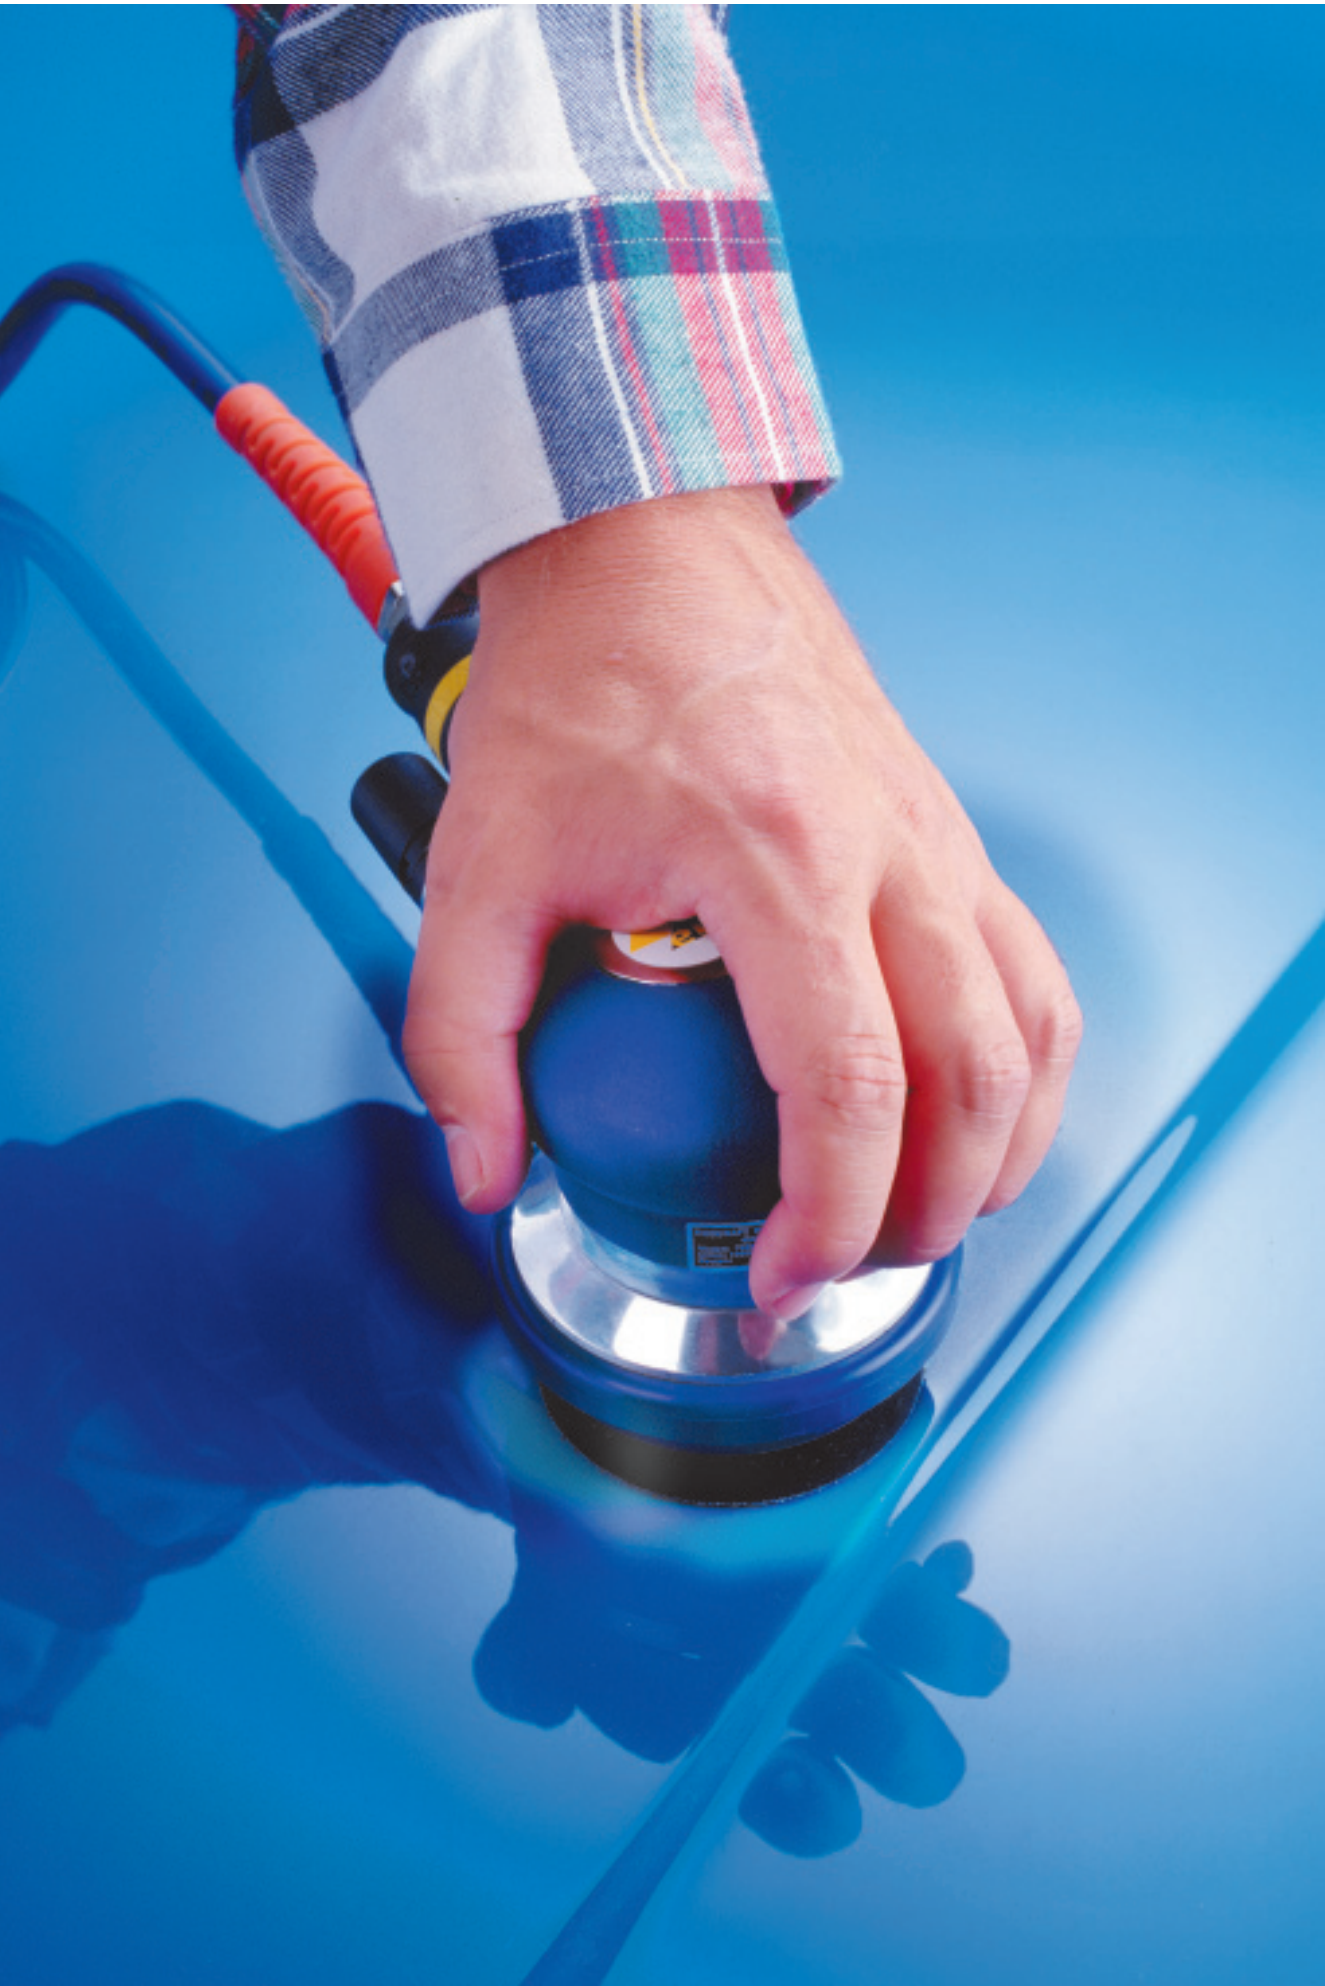
# Spot Repair System

### Systemkoffer

Zonder inhoud  
T9015.0000.1

### Handblok

Rond met microklittenband  
Ø 77 mm  
T8996.0000.1

### Intermediate pad

met microklittenband  
Ø 77 mm  
T8997.0000.8

### siacar 1941

siafast, Ø 80 mm  
P180/280/400/800  
T8998.xxxx.6

**Rodcraft Excenter  
Schuuruitslag  
2,5 mm, Incl. steun-  
schijf Ø 77 mm**

## Krassen in de lak

RC-Excenter/Handblok  
siacar 1941/P400

Overgang van te repareren plek  
siacar 1941/P800  
met Intermediate pad

## Krassen met onderliggende roest

RC-Excenter/Handblok  
siacar 1941/P180 + P280

Overgang van te repareren plek  
siacar 1941/P400  
met Intermediate pad

## Deuk

RC-Excenter/Handblok  
siacar 1941/P180

Plamuur  
Voorschuren P180 + P280  
Naschuren P400  
met Intermediate pad

## Schuren van Filler

zonder Intermediate pad  
siacar 1941/P400 + P800

Naschuren met Intermediate pad  
siamic 1990/P1200

Overgang en spotbereik met RC-Excenter  
siavlies met siafast/K600 of microtc 1790/K2000 (vochtig)
